## Data

## Vehicle Data

<b>VIN number:</b> 7M7SWEDRFGTY77879	<b>Plate Date:</b>	<b>Brand:</b>	<b>Model:</b>	<b>Type:</b>
<b>Manufacturing/Model:</b>		<b>Mileage:</b> 123456		
<b>Title Number:</b>

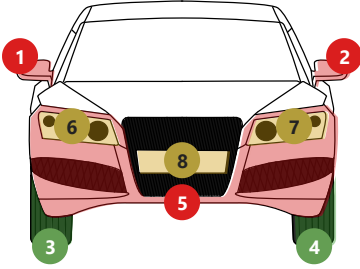
Front (External)

**1** Damaged  
Right mirror

Description: Light wear, Moderate wear, Advanced wear

**2** Damaged  
Left mirror

Description: Damaged component

**5** Damaged  
Front bumper

**6** Note  
Right headlight

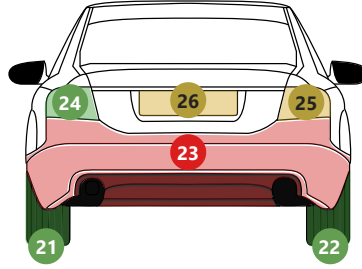
Rear (External)

23 Damaged  
Rear bumper

Description: With filler

25 Note  
Rear right tail light

Description: Recovered
